BURLINGTON
HIGH SCHOOL

STRUCTURAL
EXISTING CONDITIONS REPORT
MAY 20, 2024

Burlington High School
Burlington, Massachusetts
Structural Assessment
May 20, 2024

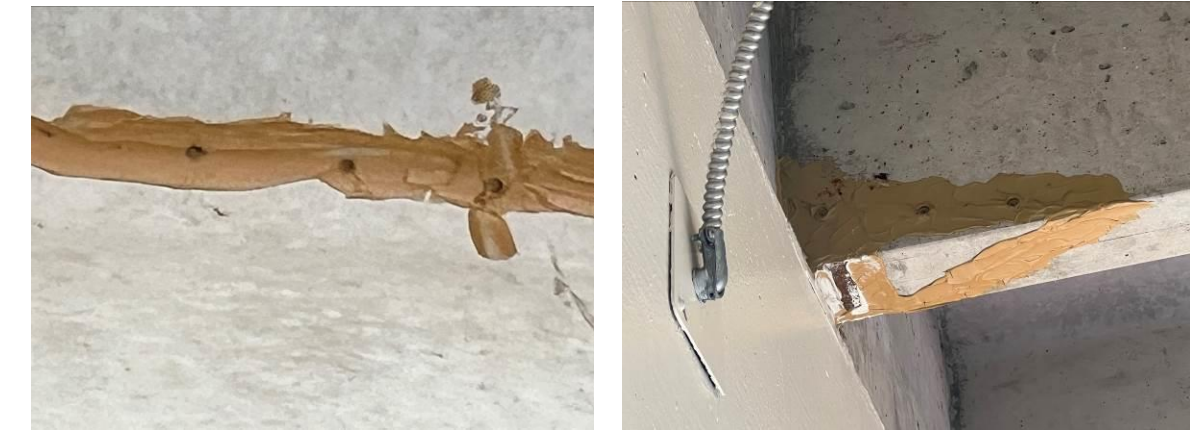
We observed some signs of leaks in the ceilings. We observed cracks in the stems and flanges of the exposed precast concrete double tees that have been repaired in the past. We did not see any connections between the top of the interior masonry walls and the structure.

Example of past repairs to the flanges and stems of the precast concrete double tees

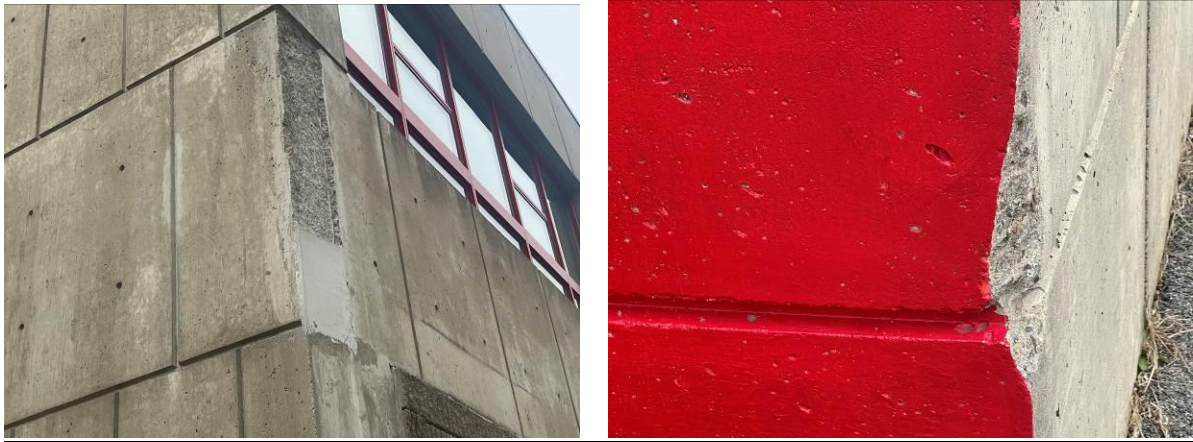
The exterior façade is cast-in-place concrete for the most part, we observed some damage to the walls at the corners and observed past repairs to the surface of a portion of a wall where the original concrete has spalled.

Damage to the exterior concrete facade
