## Burlington High School Accessibility Survey

July 30, 2021

**Prepared for:**  
CBI Consulting  
250 Dorchester Avenue  
Boston, MA 02127

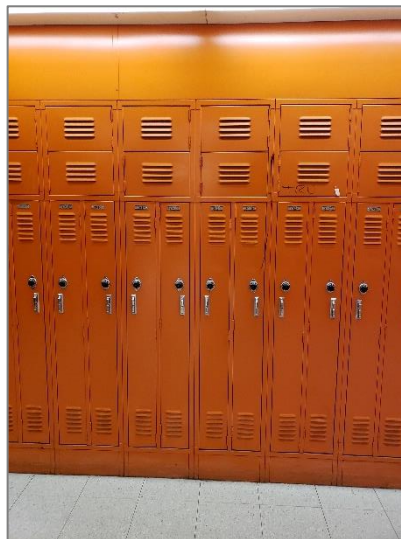
FIGURE 2: LOCKER DEFICIENCIES

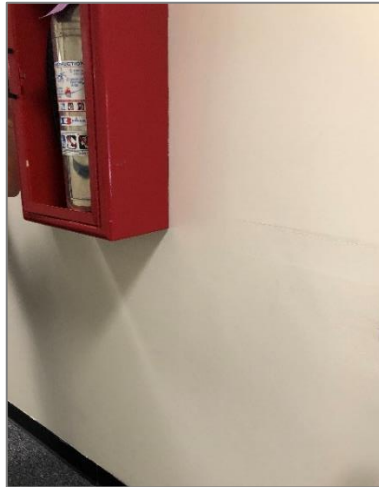
Accessible routes are generally provided within each floor of the building, but fire extinguishers protrude more than 4 inches into the hallway. Objects protruding from walls with their leading edges between 27 and 80 inches are limited to 4" projections (521 CMR 20.6.1).

FIGURE 3: FIRE EXTINGUISHER PROJECTION

| DEFICIENCY ID | LOCATION | APPROXIMATE NUMBER OF LOCATIONS | DEFICIENCY DESCRIPTION | CODE REQUIREMENT | 521 CMR CODE REFERENCE | RECOMMENDED CORRECTIVE ACTION |
|---|---|---|---|---|---|---|
| 32 | General Building/ Accessible Route | 13 | Fire Extinguishers provided in hallways project 4.5-8.25 inches into the hallway. | Objects projecting from walls shall protrude no more than 4 inches into walks, halls, corridors, passageways, or aisles. | 20.6.1 | Replace the fire extinguisher cabinets such that the project is less than 4 inches. |

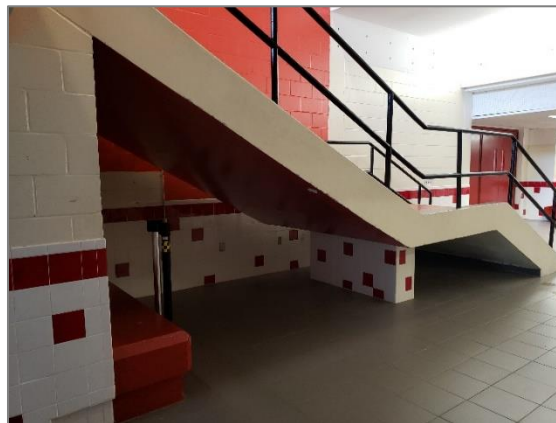
Adjacent to the open stairs which lead to the several gyms, both the stair run and the landing above provide less than adequate head room for occupants. Headroom is required to provide 80" of clear space. Where the headroom is reduced, a barrier (i.e. cane detection) is required to be provided to warn blind or visually impaired persons of the reduced headroom. Under the stair run, a railing or bench seating or the like could serve as this barrier. Options for alleviating the inadequate headroom at the stair landing should be explored as this is along an egress path.

FIGURE 4: STAIR HEADROOM REDUCTION MISSING CANE DETECTION

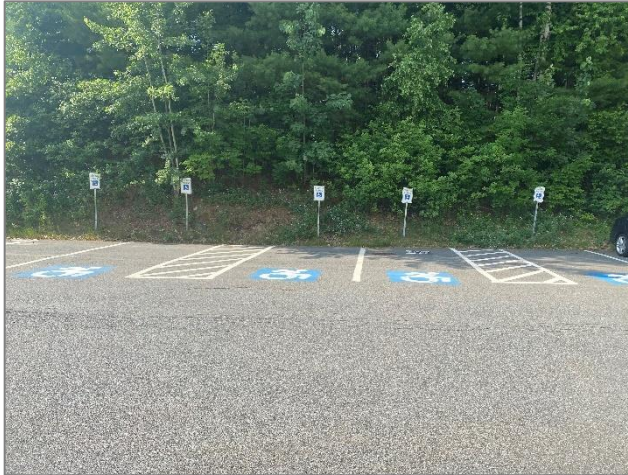
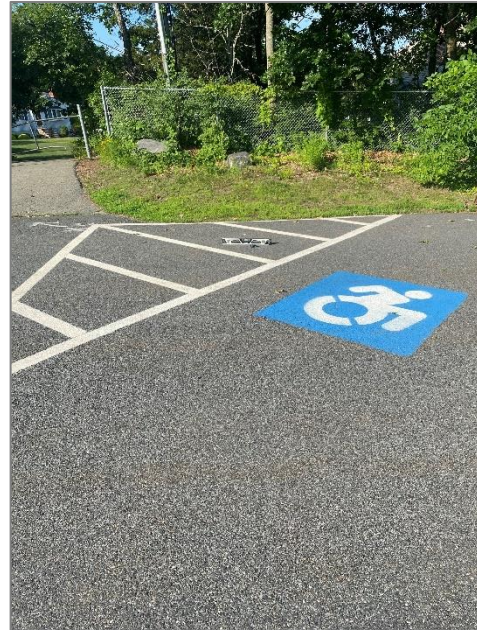
- Accessible parking spaces are required be at least 8' wide to comply with 521 CMR Chapter 23.4.1, generally less than 8' provided.
- Accessible parking spaces cannot have a slope exceeding 2% in accordance with 521 CMR 23.4.3, generally 3%-5% provided.
- Each accessible parking space is required to be provided with an accessible parking sign that complies with 521 CMR 23.6. Some accessible parking signs were missing, and many were not of the required height or distance from the parking space.

FIGURE 5: ACCESSIBLE PARKING SPOTS

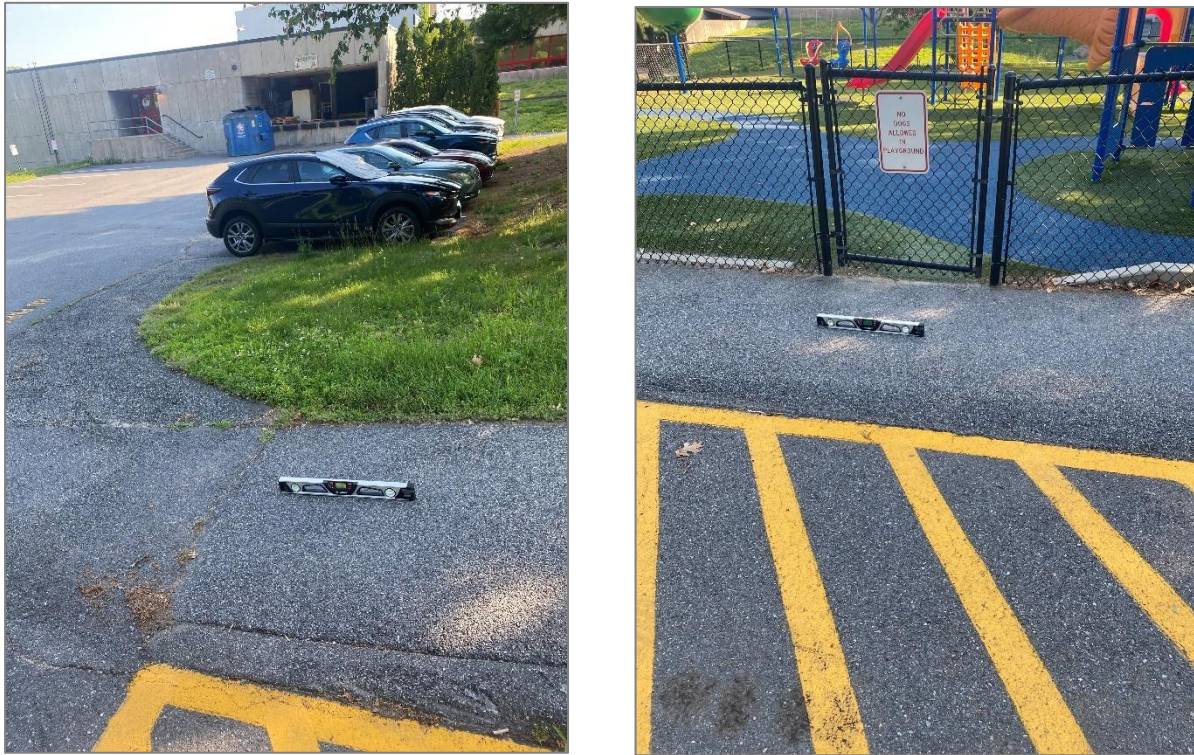
- Along the exterior sidewalk route, a significant number of locations were identified where the running slope exceeded 5% and does not comply with any requirements to be considered a ramp. According to 521 CMR 20.9, An accessible route with a running slope greater than 5% shall comply with 521 CMR 24.00: Ramps.
- A significant number of locations provided a cross slope greater than 2%. 521 CMR 20.9 states that nowhere shall the cross slope of an accessible route exceed 2%.

FIGURE 6: EXTERIOR ROUTE DEFICIENCIES

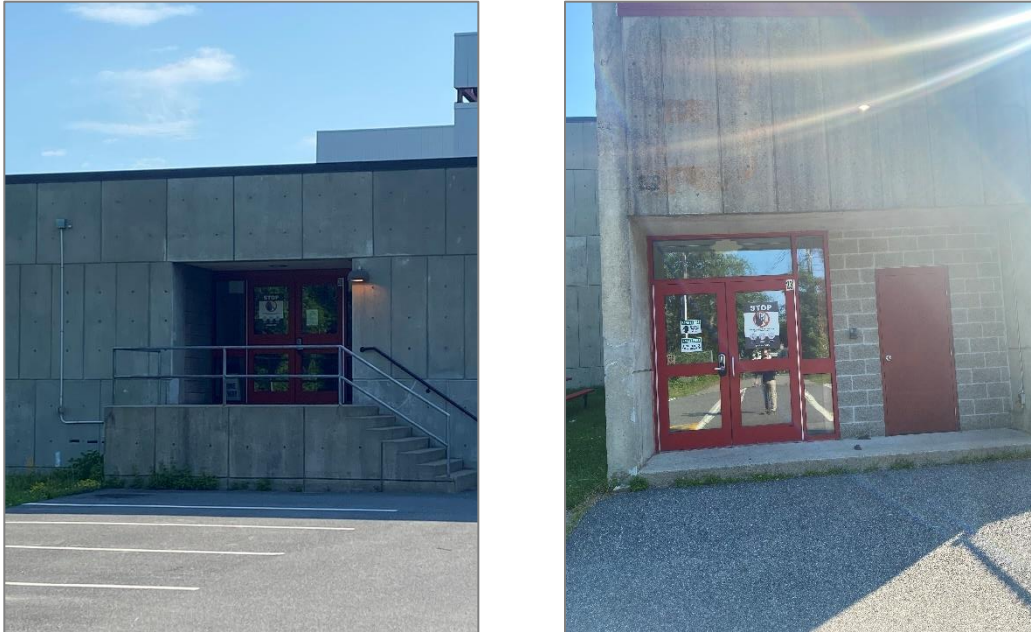
Multiple of the building entrances are currently inaccessible as they include steps leading up to them. All public entrances are required to be accessible and cannot include steps, stairs, or slopes greater than 8.3%. All public entrances must comply with 521 CMR Chapter 25.00. Exterior doors around the building were observed to have thresholds greater than 0.5 inches in height (521 CMR 26.10.1).

FIGURE 7: PUBLIC BUILDING ENTRANCES

An option for resolution on these is to re-evaluate whether the doors are required to be entrances. Doors designated as staff-only entrances or "exit only" are not required to comply as an entrance.

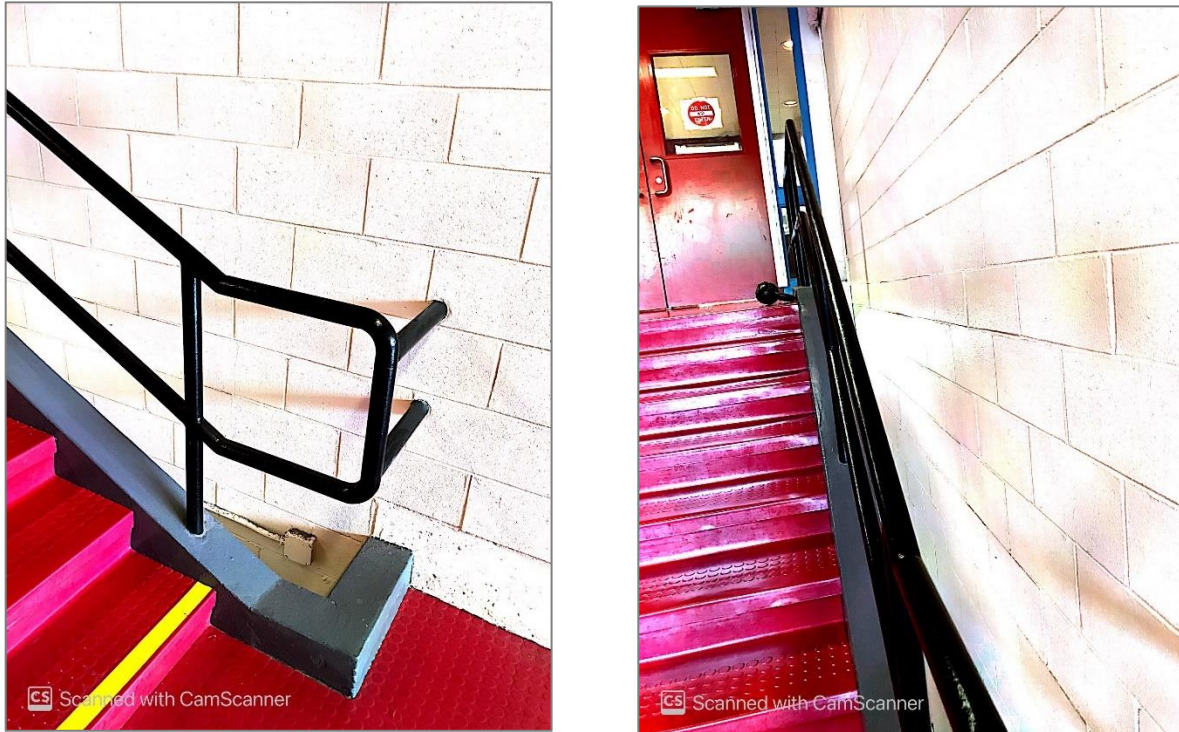
- Stair tread depth and riser height, required to comply with 521 CMR 27.2, are generally noncompliant as they are not uniform.
- Handrails, required to comply with 521 CMR Chapter 27.4, are generally noncompliant as they are not provided in some locations or have insufficient extensions. Handrails are also required to have a clear space of 1.5" between the handrail and adjacent side wall, which typically did not comply.

FIGURE 8: STAIR DEFICIENCIES

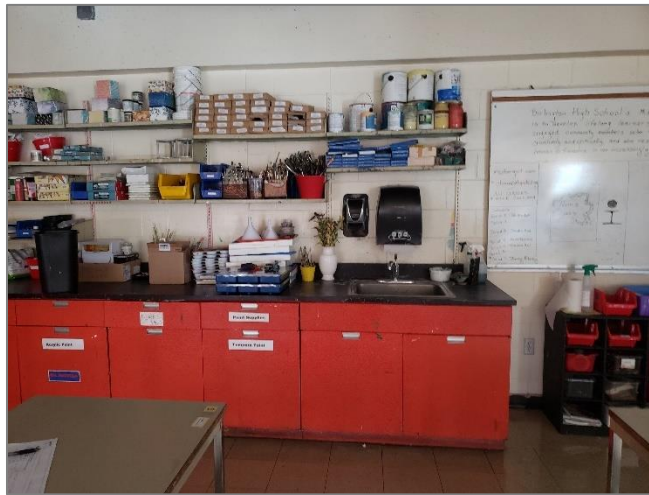
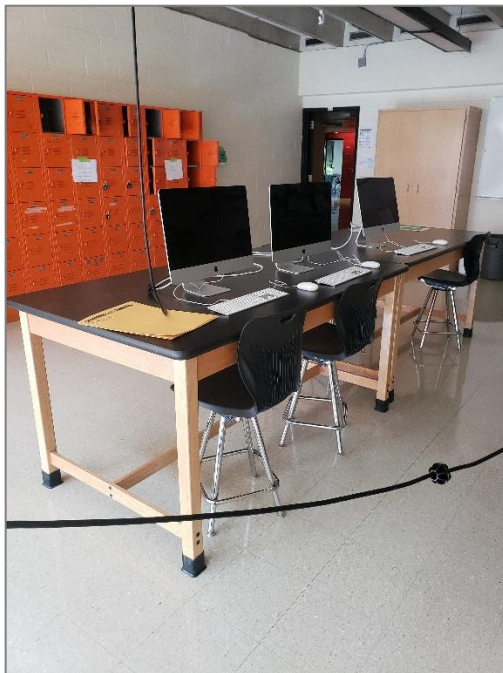
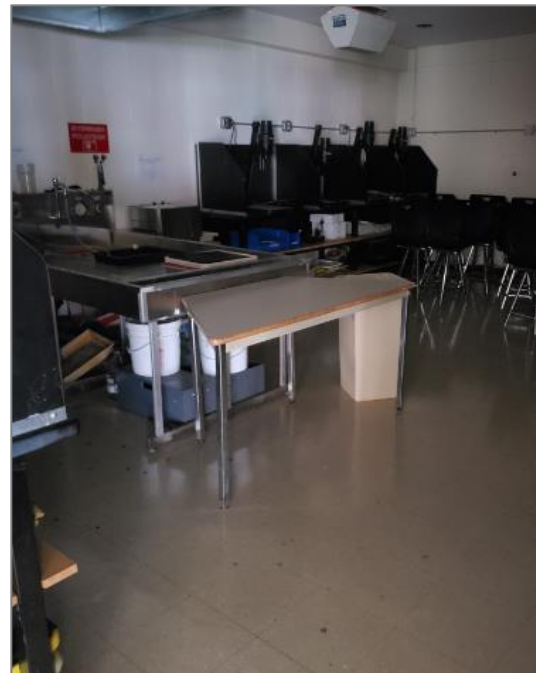
The physics room located on the First Floor as shown in Appendix A contains a sink for laboratory purposes. The sink is inaccessible according to 521 CMR Chapter 12.2.2 including excessive height and improper knee clearance. The art spaces on the Second Floor contain sinks that are inaccessible according to 521 CMR Chapter 12.2.2 because no knee clearance is provided (graphics room and dark room). Additionally, workstations in the art spaces were measured to be above 34" in height and not provide knee and toe clearance. 5% with a minimum of one of each element are required to be accessible and comply with 521 CMR Section 12.2.2. Specific deficiencies associated with the physics room and art spaces are noted in the Appendices.

FIGURE 9: ART ROOM & DARK ROOM

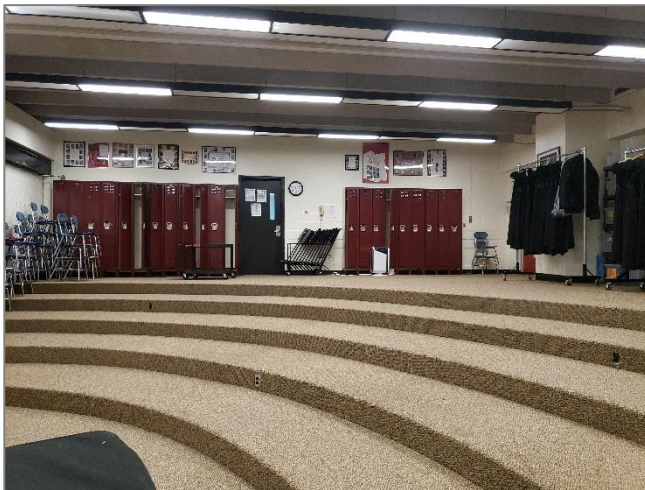
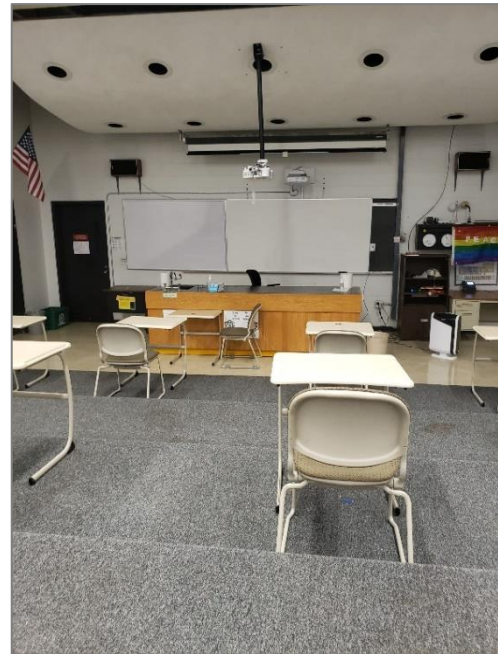
The choir room, band room, and lecture hall all on the First Floor, as shown in Appendix A, contain tiered floors. The rooms do not provide an accessible route to the performing areas of the band room and choir room. Based on the length of the tiers in the band and choir rooms, there is potential for the room to accommodate more than 150 people, requiring accessible seating to be dispersed. Within the lecture hall, there are provided desks, none of which are accessible. Additionally, an assistive listening system was not observed for any of these rooms in accordance with 521 CMR 14.5.1. Specific deficiencies associated with these rooms are noted in the Appendices.

FIGURE 10: CHOIR ROOM & LECTURE HALL

Alleviating these deficiencies would include studying an accessible route to the bottom of the tiers either via a ramp per 521 CMR 24.00 or lift per 521 CMR 28.00, installing an assistive listening system for assembly spaces in accordance with 521 CMR 14.5, and providing accessible seating options. If the choir and band room are fixed at 150 or less, the accessible seating would be permitted to be in one location rather than dispersed.

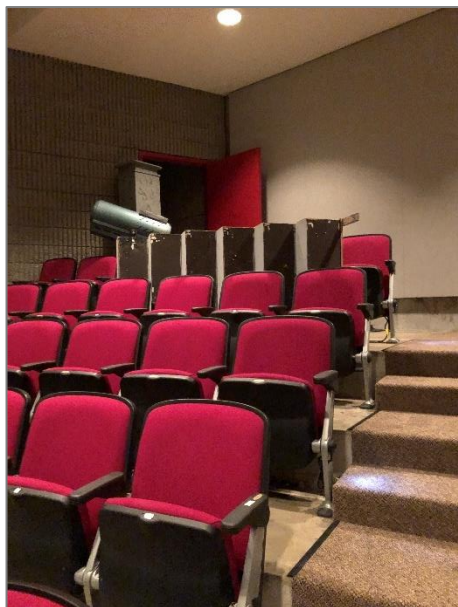
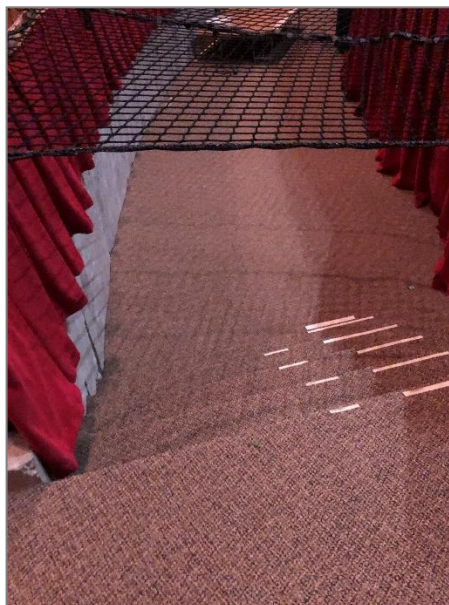
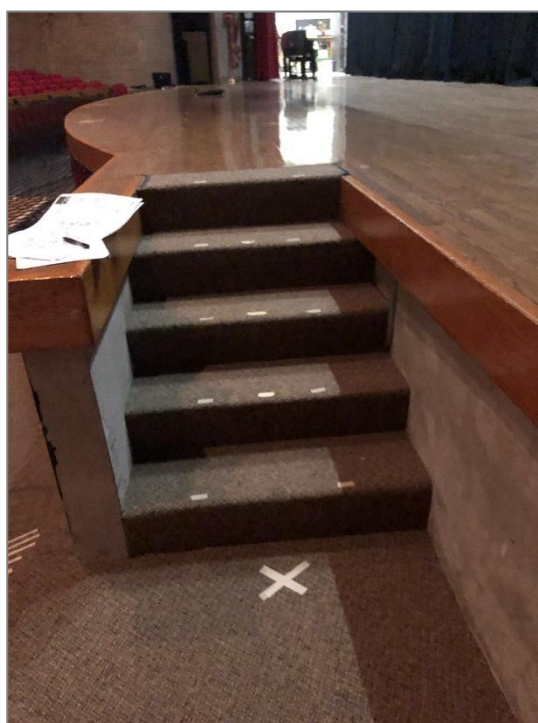
No accessible seating is provided for the space. Based on the 789 fixed seats that were observed, a total of 9 accessible spaces complying with 521 CMR 14.4 would be required (521 CMR 14.2).

The accessible route throughout the space is noncompliant. There is no accessible route to the orchestra pit, stage, sound booth, or upper section of seating. Where stairs are provided to these spaces, they are not provided with handrails on both sides. In addition, the ramps provided down the aisles of the lower seating exceeded the maximum permitted slope of 8.3% by almost double. It should be studied whether a compliant set of ramps can be installed, noting that ramps are limited to a 30 foot run before a compliant landing is required. A lift to access these areas should also be considered.

FIGURE 11: AUDITORIUM

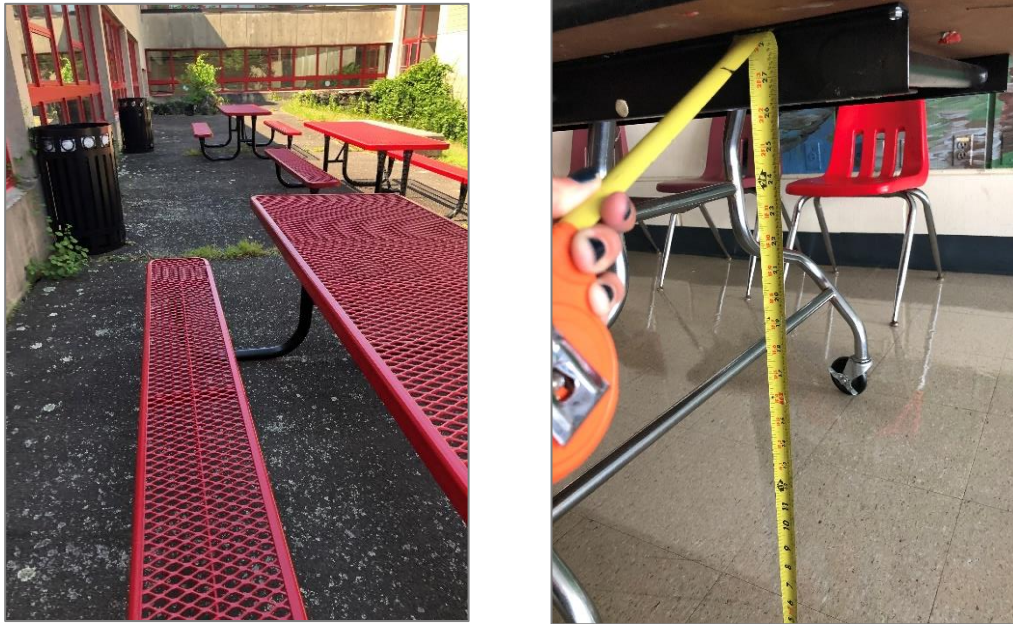
The school's cafeteria is located on the First Floor, as shown in Appendix A. No accessible route or accessible seating is provided in the outdoor dining area. Additionally, none of the indoor seating is compliant as it does not provide adequate knee clearance. Specific deficiencies are noted in the Appendices.

FIGURE 12: CAFETERIA SEATING

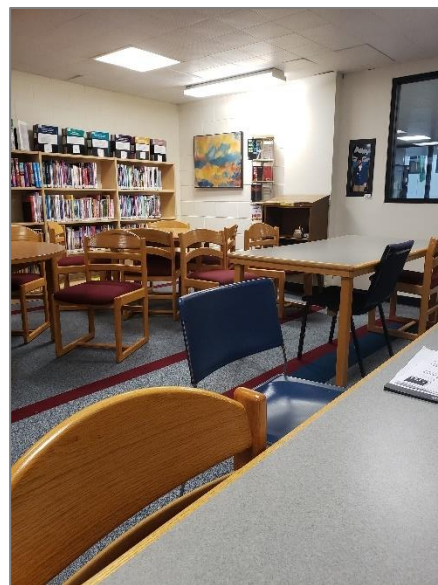
The school's library is located on the First and Second Floors, as shown in Appendix A. The library tables and seating areas do not provide any accessible seating. According to 521 CMR 12.2.2, at least 5% of the seating must be accessible and on an accessible route. Additionally, the mezzanine level overlooking the library is only accessible by stairs and therefore is not located on an accessible route. It should be confirmed whether the mezzanine is intended to function solely as an employee-only space. Other specific deficiencies associated with the library are noted in the Appendices.

FIGURE 13: LIBRARY

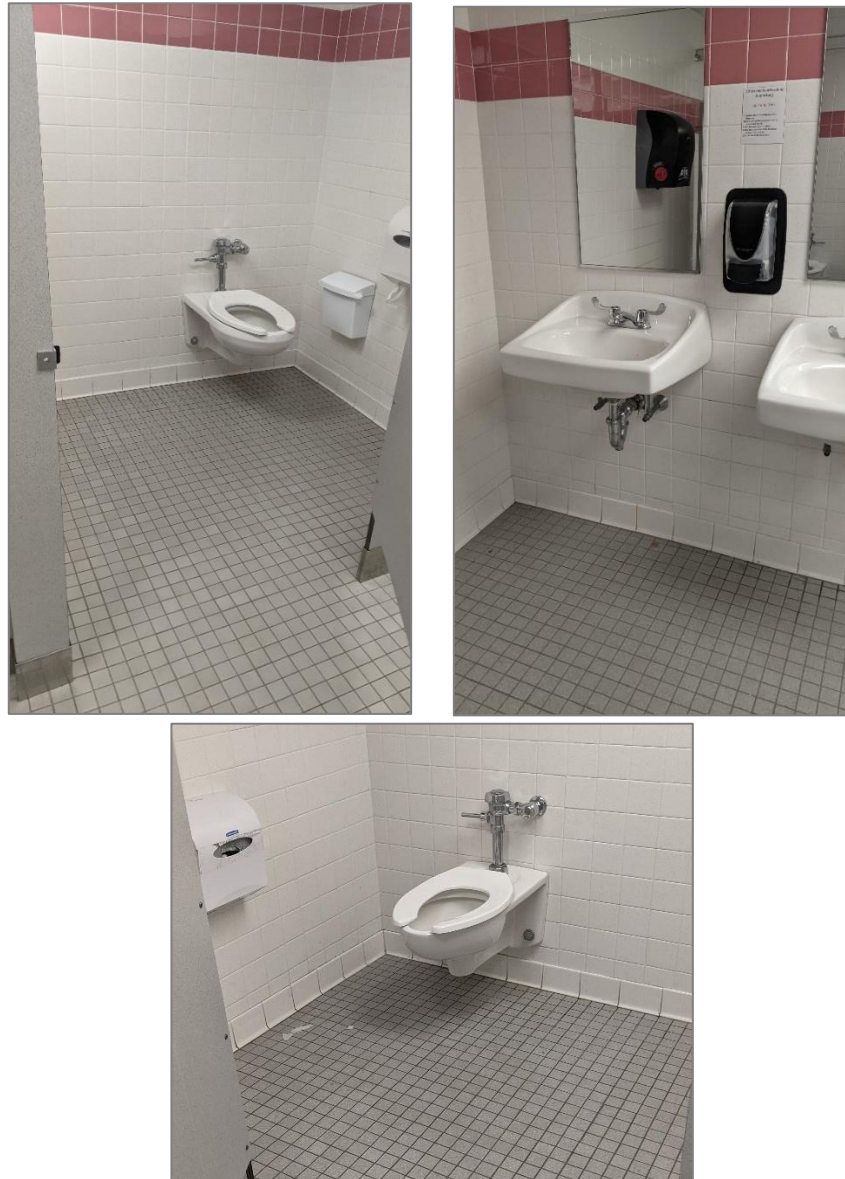
FIGURE 14: MULTI-STALL BATHROOM DEFICIENCIES

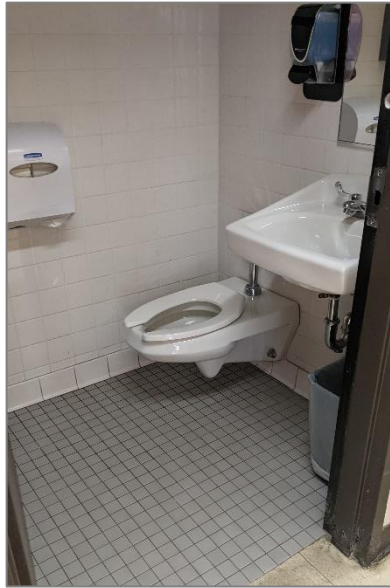
Generally, the bathrooms are noncompliant. All of the single user toilet rooms, including the health's office single users, staff and student single users throughout, were found to not meet the minimum dimensions required per 521 CMR, 72" x 90".

FIGURE 15: SINGLE USER BATHROOM EXAMPLE

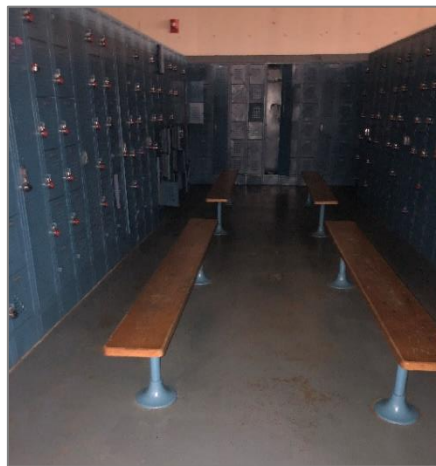
- No accessible restroom stalls or showers are provided which is required by 521 CMR 30.1 and 31.1. Additionally, urinals and sinks were observed to be noncompliant.
- The aisle between benches and lockers is less than 36". There must be an aisle at least 36" wide according to 521 CMR 19.4.2.

FIGURE 16: LOCKER ROOM DEFICIENCIES

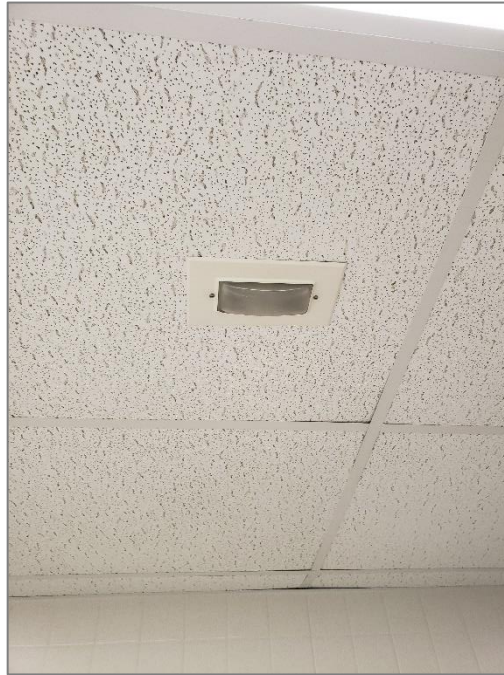
FIGURE 17: VISUAL ALARM NOTIFICATION DEVICE IN RESTROOM

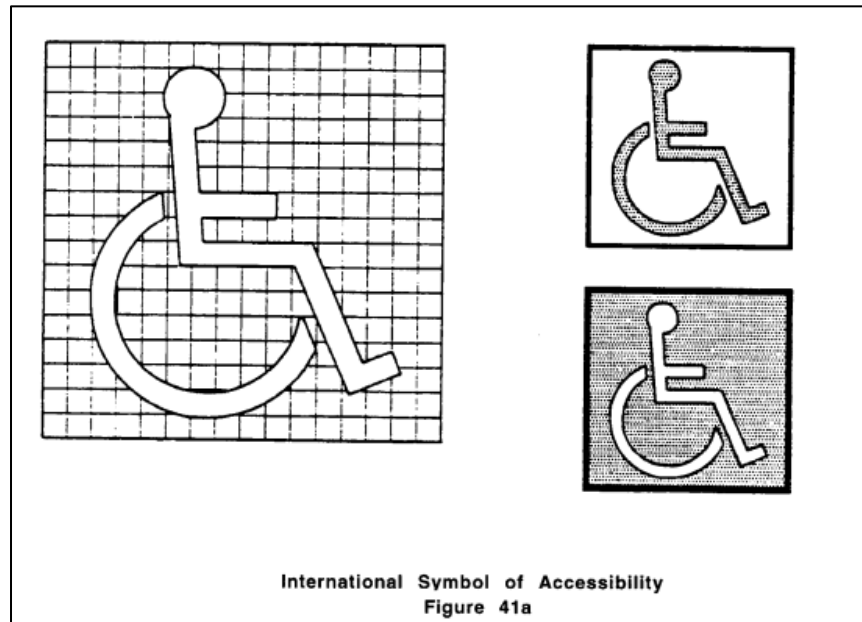
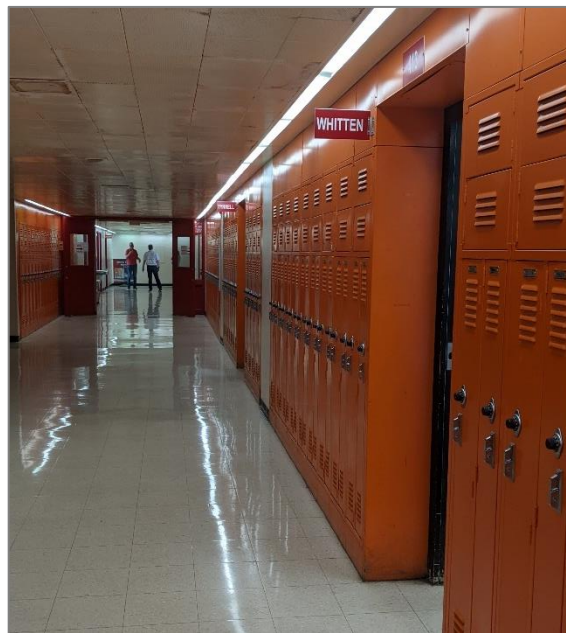
Signage throughout the building was observed to be noncompliant. Signage must be compliant with 521 CMR 41.00. The major following requirements apply:

Additionally, elements and spaces of accessible facilities including emergency egress signs are required to be provided with the International Sign of Accessibility. None of the exit signs within the building were provided with this signage.

FIGURE 18: TYPICAL ROOM SIGNAGE
