## Burlington High School Accessibility Survey

July 30, 2021

**Prepared for:**  
CBI Consulting  
250 Dorchester Avenue  
Boston, MA 02127

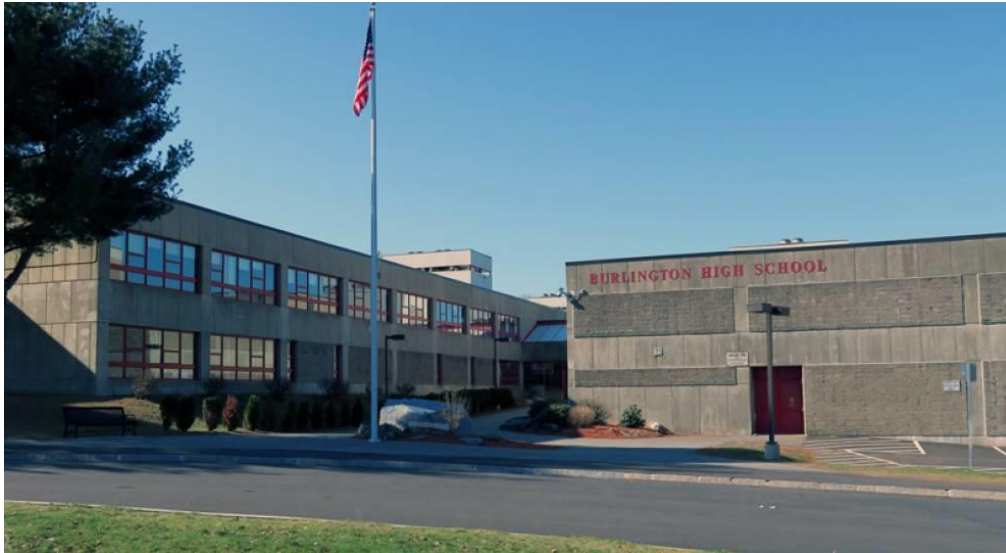
FIGURE 1: EXISTING BUILDING

Burlington High School is an existing 3-story building with an aggregate area of approximately 414,500 square feet and a maximum footprint of approximately 245,600 square feet. Building uses include a cafeteria, gymnasiums, auditorium, computer labs, library, classrooms, and non-public staff offices and lounges. There is also a daycare within the building and two playground areas outside the building.
