BURLINGTON
HIGH SCHOOL

TAPPÉ
ARCHITECTS

MECHANICAL
EXISTING CONDITIONS REPORT
MAY 28, 2024

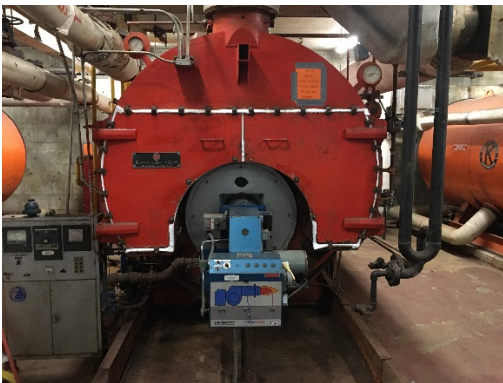
Photo 1 - Boiler

The existing mechanical room is located toward the back, lower portion of the building. The mechanical room is equipped with three (3) gas fired, fire tube boilers, Kewanee model H2W-300-K boilers, rated for 300 boiler horsepower each. There are three (3) hot water lead/standby base mounted circulating pumps which pump water to eight (8) secondary single primary pumps within the building serving the building heating systems. The existing boilers, pumps and associated equipment were installed back in 1972 and are in various levels of disrepair.

Existing boilers will be replaced with new high efficiency condensing boilers. Main system and secondary pumps will be replaced with new high efficiency pumps with variable frequency drive (VFD) motors.

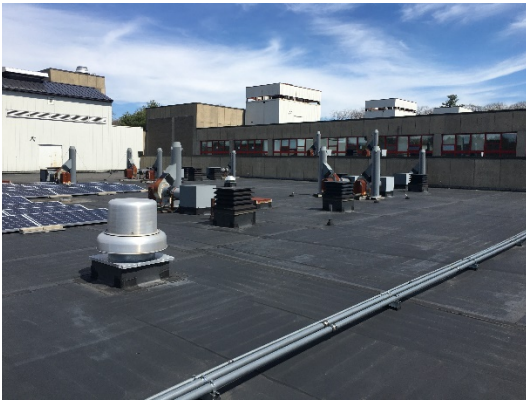
Photo 3 – Rooftop Exhaust Fans

Restrooms and gang bathrooms are exhaust through exhaust registers on the ceiling and rooftop exhaust fans. Controls are operated continuously during occupied hours and do not operate during unoccupied hours. Heating is provided by hot water terminal equipment.

Exhaust fans and exhaust registers will be removed and replaced with new. Existing ductwork will be reused as much as possible and cleaned.

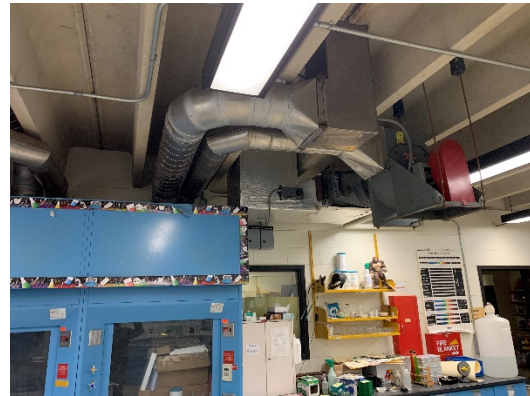
Photo 4 – Exhaust Hood with Make-up Air Fan

The science classrooms are provided with chemical exhaust hoods with controls and make-up air systems that do not appear to be functioning and appear to have failed.

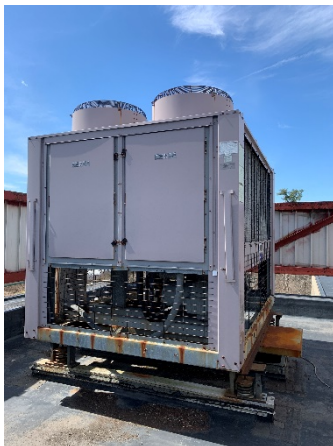
Photo 5 – Air-Cooled Condensing Unit

The existing school is equipped with a natural gas fired, hot water heating system and DX cooling system with boilers, pumps, air-cooled condensing units, rooftop air handling units, variable air volume units with hot deck-cold deck, pneumatic controls, and sporadic electronic controls. A majority of the equipment is original to the building, beyond its useful life, is in disrepair and in need of replacement.

Main heating equipment and rooftop air handling equipment serving the classrooms, administration area, library, auditorium, and cafeteria will be replaced with new, high efficiency equipment with new air-cooled condensing unit and energy recovery to meet new energy conservation codes.

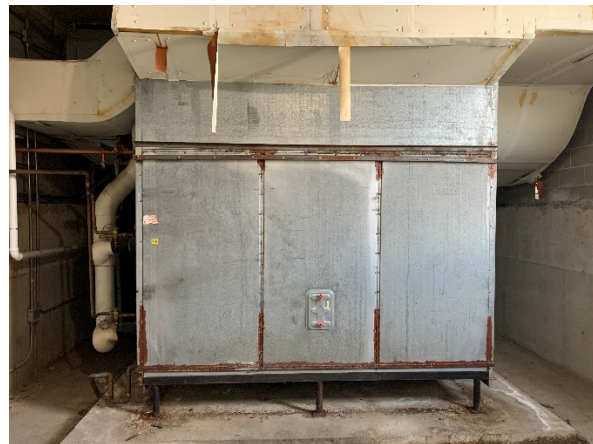
Photo 6 – Penthouse Air Handling Unit

The Classrooms, Administration area, Library, Auditorium, and Cafeteria are provided with heating, ventilating and air conditioning rooftop air handling units with hot water heating hot deck/DX cooling air cold deck and return fans located in roof level mechanical penthouses. All units are original to the building and appear to be in disrepair. Each rooftop unit is provided with an air-cooled condensing unit on the top of the mechanical penthouse. Rooftop air handling units provide air through separate ductwork distribution to dual duct variable air volume terminal units that mix the cold deck/hot deck for individual zone space temperature control. The ceiling space within each zone is used as a return air plenum. Each zone has been provided with a space sensor. All spaces have also been provided with fintube radiation at the exterior walls to provide supplemental heating.

Hot deck/cold deck systems are very inefficient and will be removed for a high efficiency ductwork distribution system that will meet the new IECC and Massachusetts energy conservation codes. New terminal equipment should be removed and replaced with new and existing pneumatic controls should be removed and replaced with new electronic controls.
